## CASE STUDY: POLISHING OF AN MTBE HOT ZONE IN LOW PERMEABILITY ARTIFICIAL FILL AFTER PUMP AND TREAT

RE: Christina School District  
Maintenance and Operations Facility  
200 Salem Church Road  
Newark, DE 19713

SUBJECT: No Further Action Required - Conditional

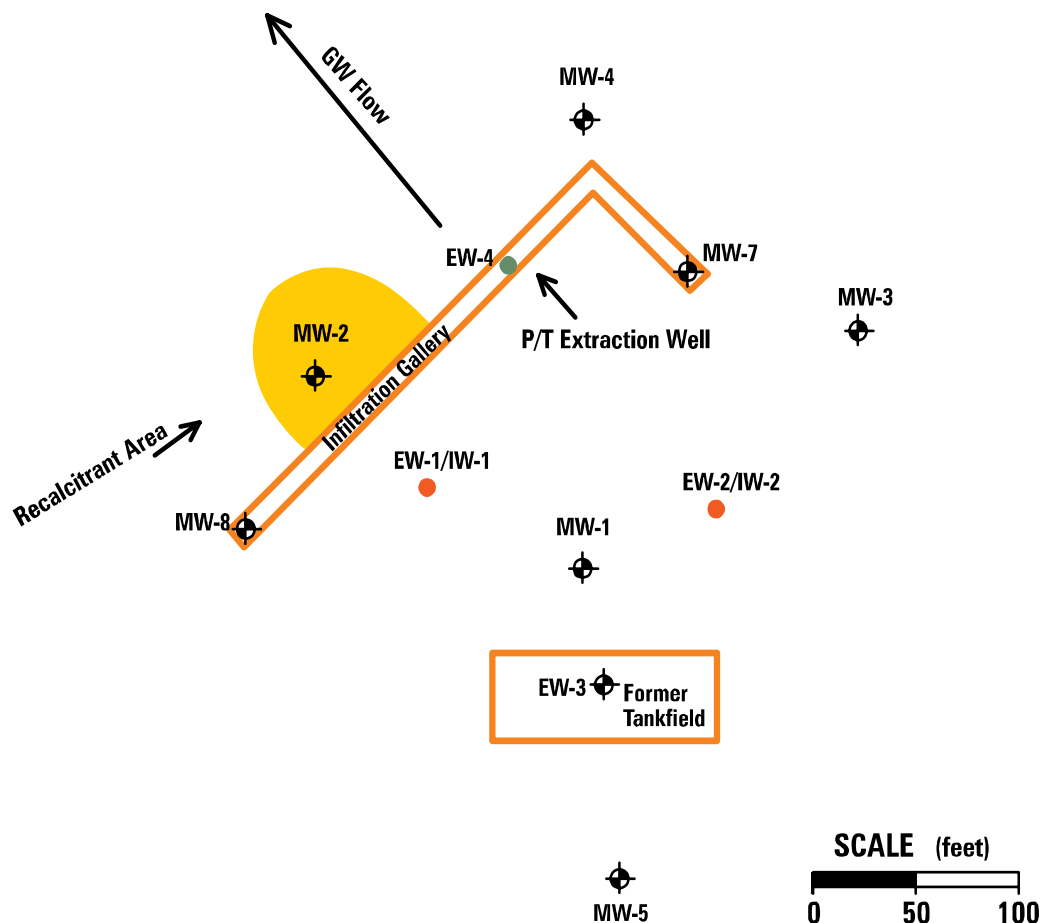
### SITE PLAN

- Pump and Treat system operated for 3 years.
- Groundwater in isolated portions of the site remained significantly above cleanup levels for MTBE.
- 2 iSOC<sup>®</sup>s used for 1 year upgradient of MW-2 and sidegradient and slightly downgradient of MW-1.
- MTBE levels were drastically reduced at MW-1 and MW-2: cleanup criteria were met.
- iSOC<sup>®</sup> system removed.
- Site is closed. A No Further Action letter was issued by the Department of Natural Resources and Environmental Control.

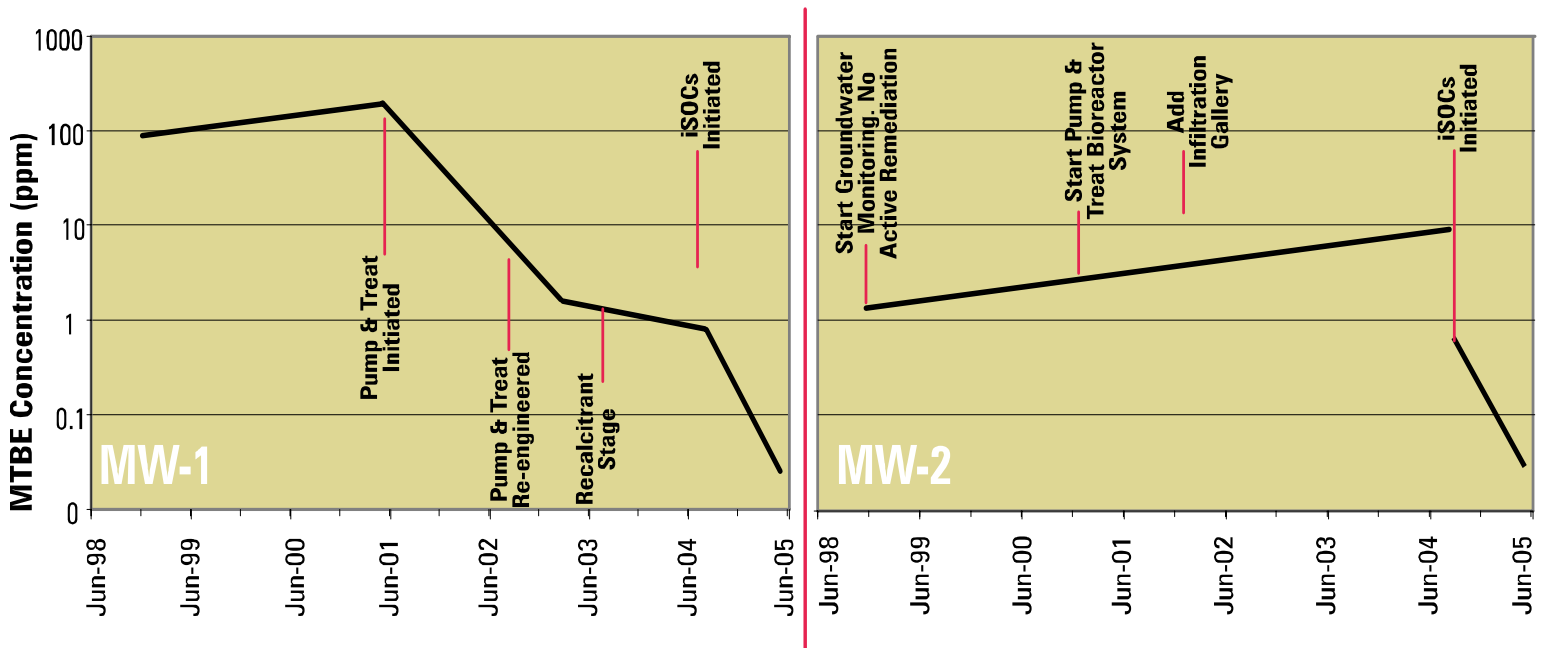
# MTBE GROUNDWATER REMEDIATION RESULTS

Other representative MTBE levels were 35,000 ppb, 22,000 ppb, and 7,000 ppb for monitoring points MW-4, EW-3 and MW-2. After three years of pump and treat, MTBE levels at MW-1, MW-4, EW-3 and MW-2 were 310 ppb, 49 ppb, Non Detect (ND), and 1,040 ppb respectively. These results illustrate limitations of a pump and treat system for treatment locations with extreme heterogeneous soil conditions. Areas with porous soils clean up readily but groundwater contamination in tight soil conditions often proves to be difficult to remediate.

This DE high school site demonstrates that implementation of strategically located iSOCs will effectively treat recalcitrant areas utilizing in situ, enhanced natural attenuation. After 1 year of enhanced bioremediation, the concentrations of MTBE in MW-1, MW-4, EW-3 and MW-2 were: ND, 229 ppb, 13.5 ppb and 21.5 ppb respectively.
